BATHROOM

QUICK FIX

Shower Enclosure Replacement

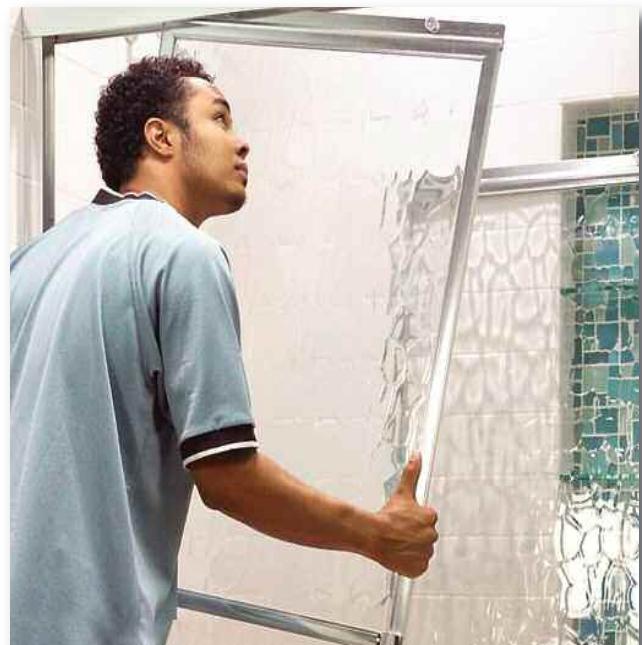
Installation of the new shower doors is the reverse of removal. The bottom track may need to be cut to size. Use

polyvinyl adhesive caulk to attach the bottom track to the tub. Don't use screws; it will cause the tub to rust prematurely. Use plastic anchors for the side rails along with polyvinyl adhesive caulk. Re-attach the head rail and doors. Avoid using the shower for 24 hours to 72 hours thereafter. —G.A.

To remove, the first step is to lift the sliding doors off of the head rail track and swing them out. Remove the screws holding the head rail to the side rail. Tap the head rail loose from the side rails using a rubber mallet. The side rails are usually bolted and caulked in place. Remove the screws (use Liquid Wrench or just drill them out if they are corroded) and pry the rails away from the wall. Be gentle so as not to loosen any tiles.

Next, remove any excess caulk from the bottom rail. The bottom track typically is glued down to the tub with adhesive caulk. It may be possible to gently tap the side of the track with a rubber mallet and break the hold of the dried-out caulk.

Look for any screws that might be holding the track to the tub. If the track remains stuck, gently pry it with a flat pry bar, use a 3/8-inch plywood backer placed approximately 4 inches to 6 inches under the pry bar so you do not damage the tile or tub. Use a putty knife to remove remaining caulk or glue. Clean the area with acetone or other suitable cleaner.
